NASA TM X-1266

EXPERIMENTAL EVALUATION
OF THROAT INSERTS IN
A STORABLE-PROPELLANT
ROCKET ENGINE

by Jerry M. Winter, Larry D. Plews, and James R. Johnston
Lewis Research Center
Cleveland, Ohio

NATIONAL AERONAUTICS AND SPACE ADMINISTRATION • WASHINGTON, D. C. • OCTOBER 1966

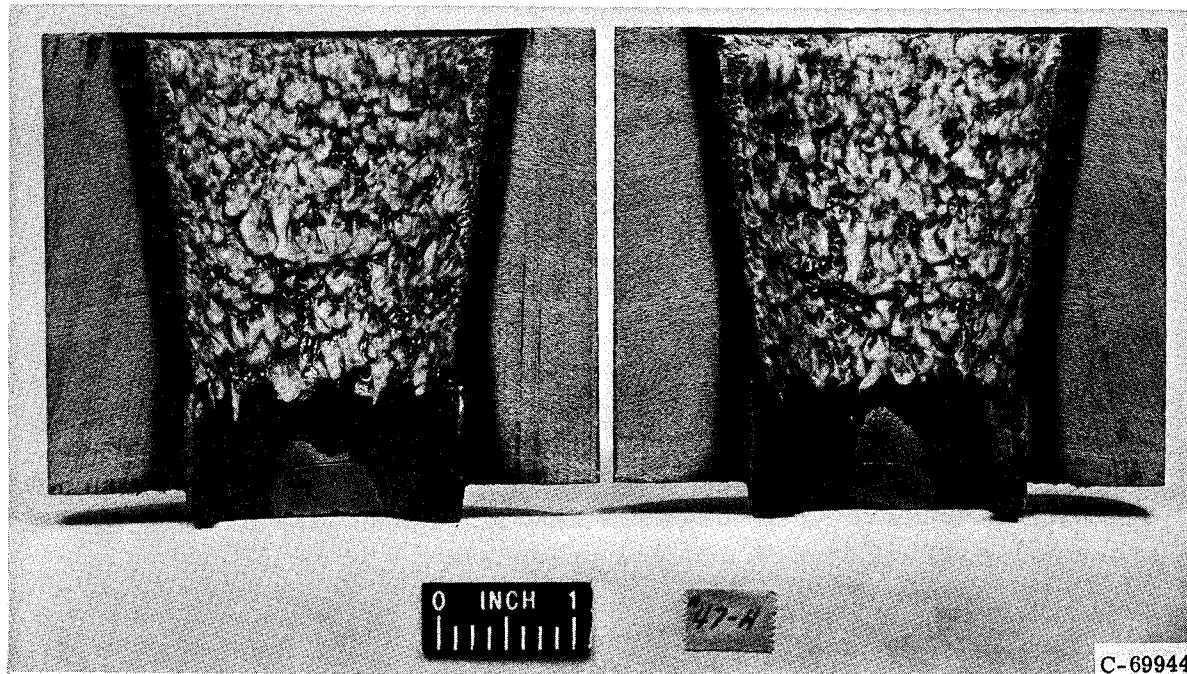
(52) Insert 52; configuration B; injector 12; characteristic length, 50

Material	Form		Manufacturer	Additional layer
Coating	0.020-in. -thick pyrolytic graphite	Pyrolytic graphite with ab axial plane			
Insert	Graphite	Pyrolyzed cloth		American Metal Products	0.040-in. -thick Rokide Z on insert outside diameter
Envelope	Silica phenolic (MX 2641)	Cloth (90° to centerline)		Haveg	0.025-in. -thick stainless-steel shell
Run	Chamber pressure, P_c , psia	Oxidant-fuel ratio, O/F	Run time, sec	Total change in effective throat radius, ΔR , in.	Remarks
213	100.5 to 102	1.82	60.0	0	Timed shutdown; coating intact
214	100.5 to 91	1.88	26.0	Not measured	Low chamber pressure shutdown; most of coating gone
			86.0

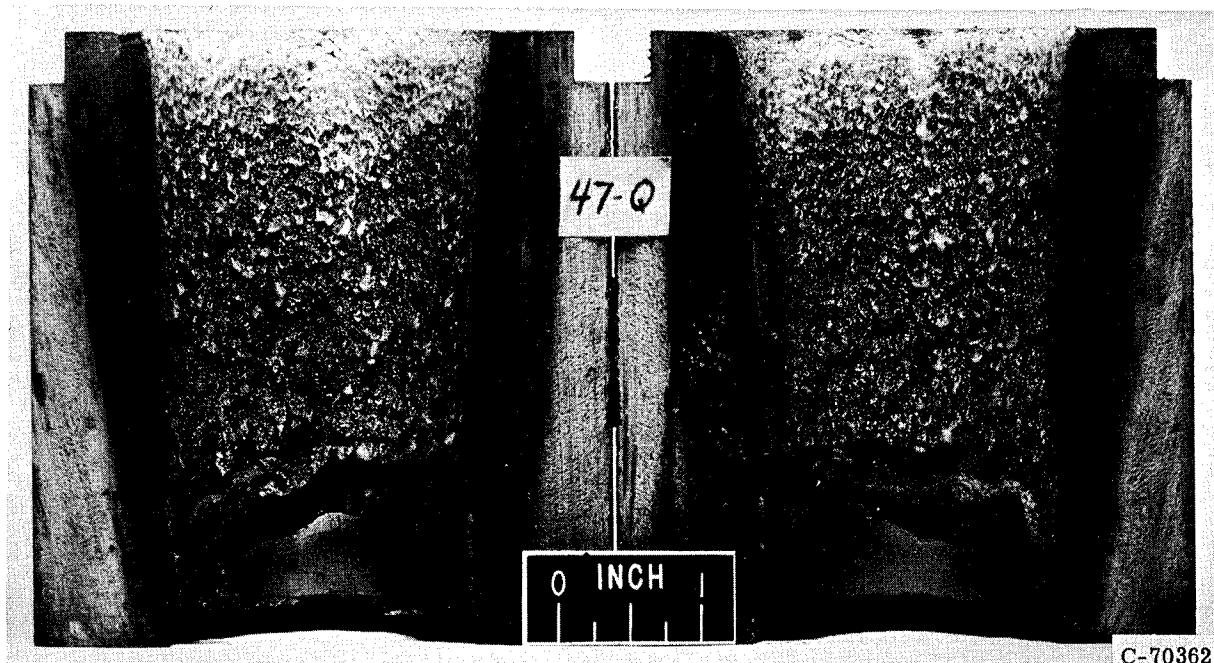
(53) Insert 53; configuration C; injector 10; characteristic length, 67

Material	Form	Manufacturer	Additional layer
Coating		0.060-in. -thick pyrolytic graphite	Pyrolytic graphite with ab axial plane		
Insert		Graphite	Pyrolyzed cloth	American Metal Products	0.040-in. -thick Rokide Z on insert outside diameter
Envelope		Silica phenolic (MX 2641)	Cloth (90° to centerline)	Haveg	0.25-in. -thick stainless-steel shell
Run	Chamber pressure, P_c , psia	Oxidant-fuel ratio, O/F	Run time, sec	Total change in effective throat radius, ΔR , in.	Remarks
262	96.5 to 95.0	2.03	59.8	0	Timed shutdown; no change
272	95.5 to 93.5	2.12	130.2	.127	Manual abort; leading edge failure
			190.0

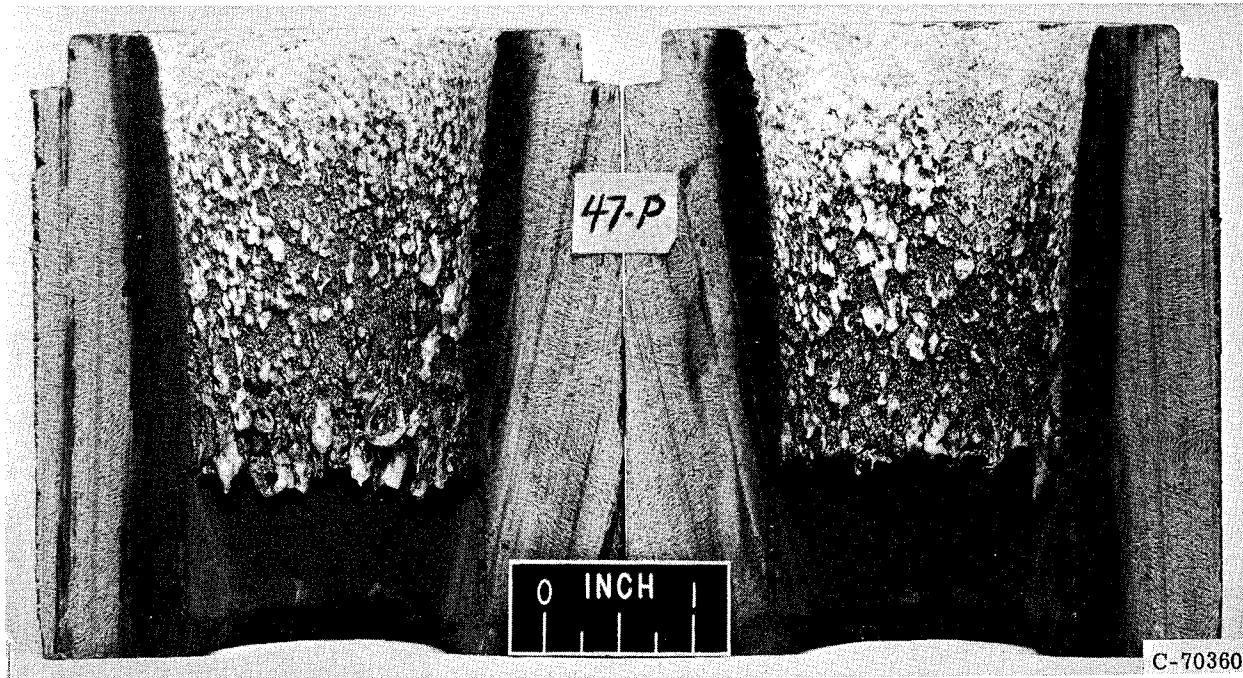
(54) Insert 54; configuration B; injector 11; characteristic length, 67

Material	Form	Manufacturer	Additional layer
Coating		0.020-in. -thick BN	Vapor deposited		
Insert		ATJ graphite	Molded	High temperature materials	0.040-in. -thick Rokide Z on insert outside diameter
Envelope		Silica phenolic (MX 2641)	Molded squares	Haveg	0.25-in. -thick stainless-steel shell
Run	Chamber pressure, P_c , psia	Oxidant-fuel ratio, O/F	Run time, sec	Total change in effective throat radius, ΔR , in.	Remarks
233	100.5 to 88	1.80	55.5	0.051	Low chamber pressure shutdown; coating completely gone
276	100.5 to 89.5	1.91	29.2	.1065	Low chamber pressure shutdown
283	97.5 to 91.0	1.85	27.6	.148	Low chamber pressure shutdown
			112.3

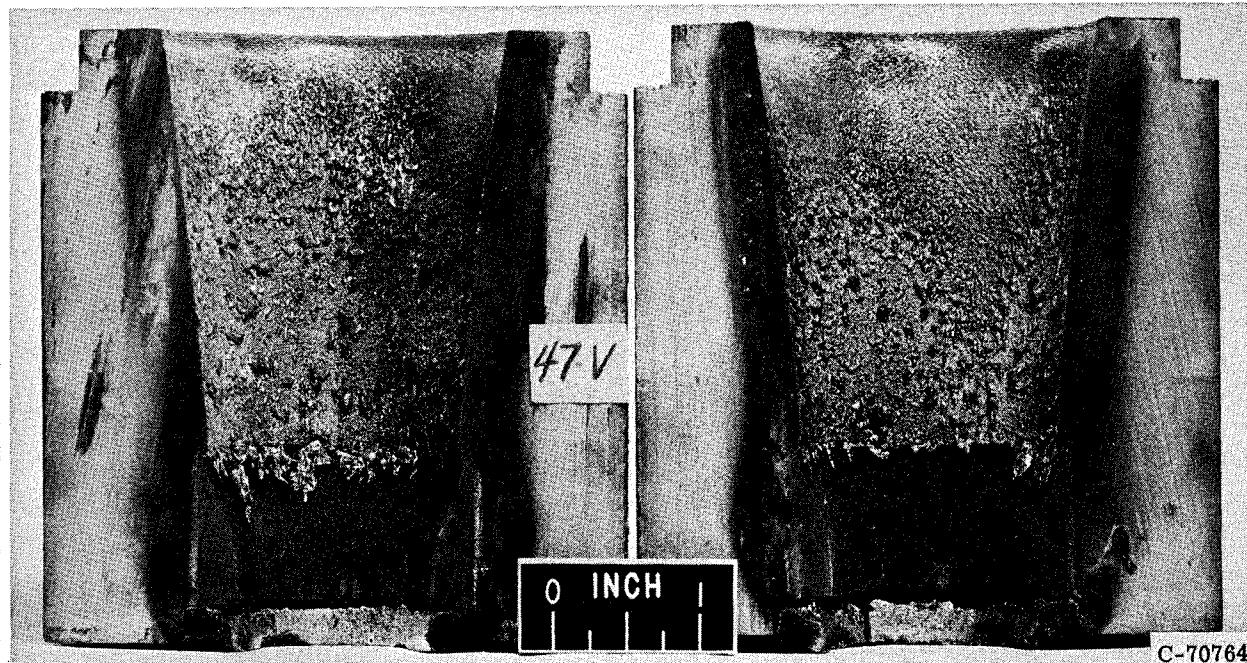
(55) Insert 55; configuration C; injector 11; characteristic length, 67

Material		Form		Manufacturer		Additional layer
Coating		0.010 in. -thick TaC		Vapor deposited		
Insert		ATJ graphite		Molded		High temperature materials
Envelope		Silica phenolic (MX 2641)		Cloth (90° to centerline)		0.100-in. -thick Rokide Z on insert outside diameter
Run	Chamber pressure, P_c , psia	Oxidant-fuel ratio, O/F	Run time, sec	Total change in effective throat radius, ΔR , in.	Remarks	
303	104.5 to 90.5	1.82	56.1	0.0725	Low chamber pressure shutdown; coating completely gone

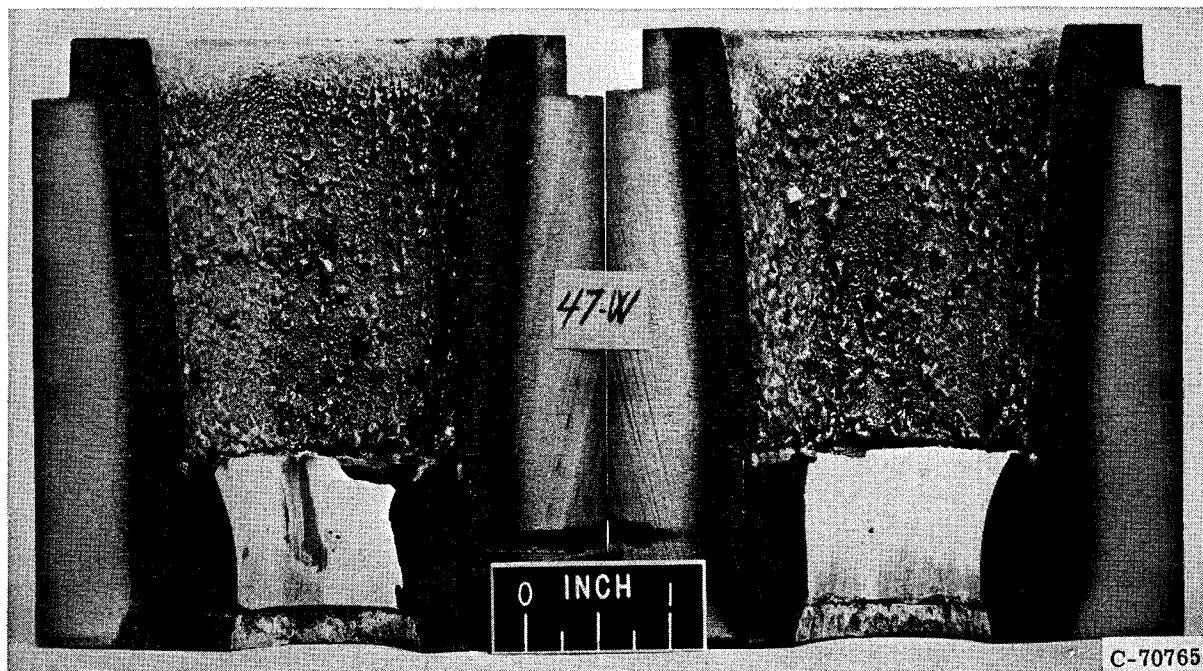
(56) Insert 56; configuration C; injector 11; characteristic length, 67

Material	Form	Manufacturer	Additional layer
Coating		0.010-in. -thick ZrC	Vapor deposited		
Insert		ATJ graphite	Molded	High temperature materials	0.100-in. -thick Rokide Z on insert outside diameter
Envelope		Silica phenolic (MX 2641)	Cloth (90° to centerline)	Haveg	0.25-in. -thick stainless-steel shell
Run	Chamber pressure, P_c , psia	Oxidant-fuel ratio, O/F	Run time, sec	Total change in effective throat radius, ΔR , in.	Remarks
300	104 to 101	1.74	60.6	0	Timed shutdown; coating oxidized and leading edge of coating gone

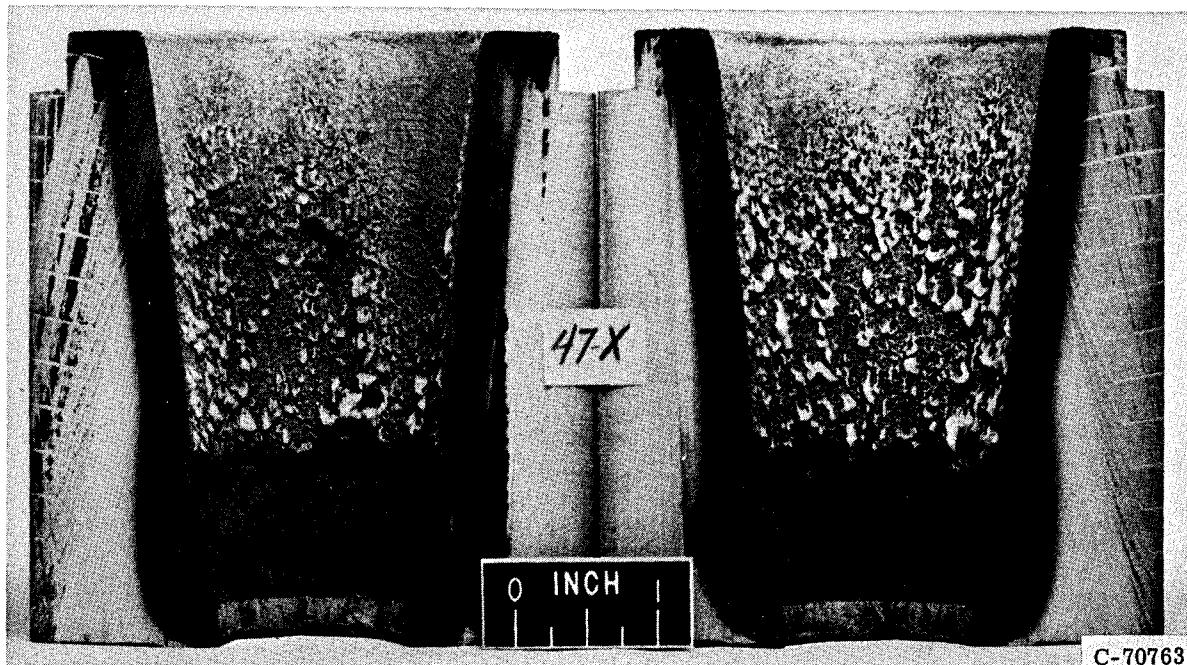
(57) Insert 57; configuration C; injector 11; characteristic length, 67

Material	Form	Manufacturer	Additional layer
Coating		0.010-in.-thick NbC	Vapor deposited		
Insert		ATJ graphite	Molded	High temperature materials	0.10-in.-thick Rokide Z on insert outside diameter
Envelope		Silica-phenolic (MX 2641)	Cloth (90° to centerline)	Fiberite	0.250-in.-thick stainless-steel shell
Run	Chamber pressure, P_c , psia	Oxidant-fuel ratio, O/F	Run time, sec	Total change in effective throat radius, ΔR , in.	Remarks
302	101.5 to 89.5	1.78	46.4	0.0615	Low chamber pressure shutdown; coating all gone
